EXPERIMENTAL STUDY OF THE EROSIONAL/CORROSIONAL VELOCITY CRITERION FOR SIZING MULTIPHASE FLOW LINES

Phase II—Experimental Results

FINAL REPORT
SwRI Project No. 04-5327

Minerals Management Service
U.S. Department of the Interior
Reston, Virginia

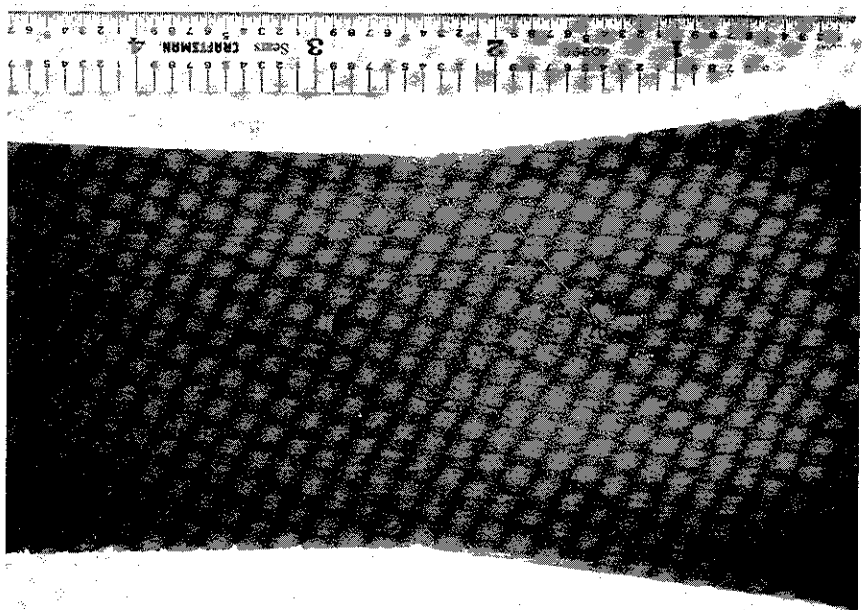
The test results showed that there was no pipe wall loss in the straight sections of pipe or in the elbows where flow was not fully developed. The only areas that showed significant wall loss were the portions of the elbows exposed to droplet impingement caused by the inability of the droplets to follow the bulk flow stream as it turned through the bends. The inertia of the droplets at the bends caused the droplets to impact the outside of the elbow with a moderately high angle of impact (not a grazing impact). The observed pits tended to grow in the downstream direction and got wider and deeper. The downstream lip of the larger wear areas had a very steep face. Some undercutting was also visible.

The rate of wall loss in the larger pits exceeded the maximum corrosion rate determined in laboratory tests, which was about 100 MPY on bare metal. For a 0.04" deep pit formed in 63 days of testing, the wear rate is about 230 MPY. Thus, the measured wear rate demonstrated that the protective corrosion products were not effective at eliminating erosion/corrosion in the elbow under the high velocity, annular mist flow conditions.

Test Fitting	Total # of Pits	Pit Depth (mils)	Pit Length (mils)
Elbow #1	33	14	200
Elbow #2	0	-	-
Elbow #3	83	40	350
Elbow #4	0	-	-

Figure 4.4 Inside Surface of Fitting #3 in Test 1. Flow is From Right to Left. Top of Fitting is Up.

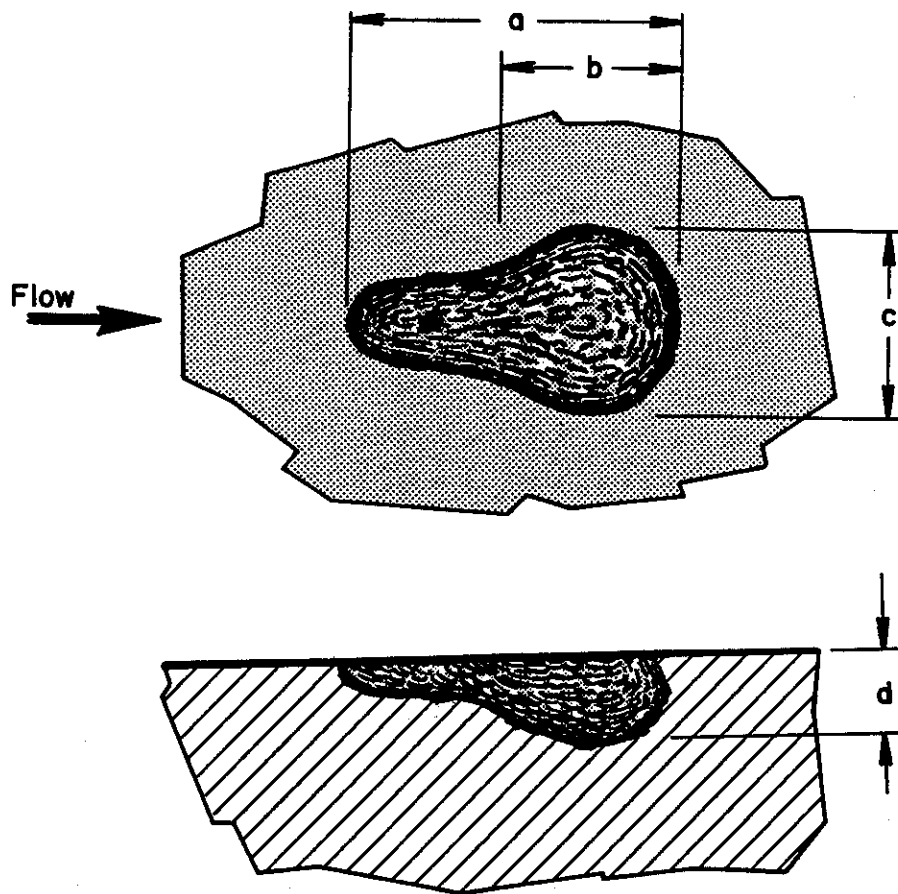
All four of the 90° elbows experienced localized pitting wear that was confined to a 1" wide band that ran along the outside portion of the bend. The pits were elongated in the direction of flow. The sketch in the Figure 4.5 presents the general shape of the pits. It appears the pits grew in the downstream direction and widened and deepened as time passed. Table 4.4 summarizes the average pit size, maximum pit size, and the approximate total number of pits for each of the four test fittings. The average and maximum pit sizes were determined by measuring individual pits that were selected as representative by visually inspecting each test fitting. With a maximum pit depth of 0.023" achieved in 60 days of testing, the maximum wear rate for the test was about 138 MPY.

Figure 4.5 Typical Erosion/Corrosion Pit Geometry.

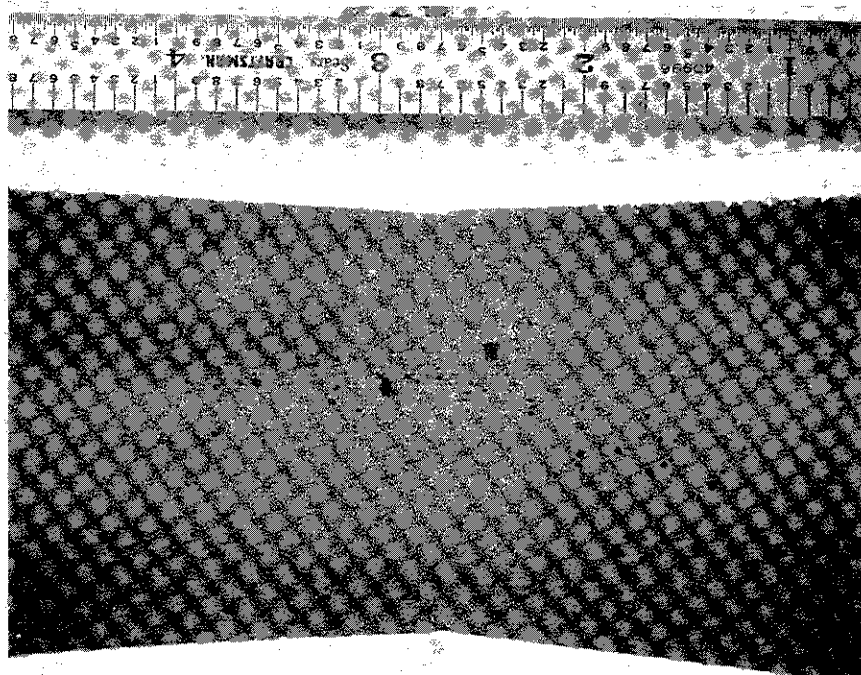
Each of the four long-radius elbows experienced pitting wear that was located along the outside radius of the elbow, between 30° and 75° from the elbow inlet (the inlet plane of the elbow being 0°). The pits were located non-symmetrically, with more pitting in the top half of the pipe and very few pits located below the centerline of the pipe. The pits located near the centerline of the elbow (that is, halfway up from the bottom of the elbow and running along the outside of the elbow) were circular and fairly small, typically about 0.030" in diameter and about 0.02" deep. The pits that were located closer to the top of the elbow were generally bigger and elongated in the direction of flow. The sizes of these pits varied considerably, with the larger pits being about 0.4" long and about 0.04" deep. Table 4.5 gives the size of the largest pit in each elbow and the total number of pits in each elbow. It should be noted that the pit depths reported here (for Test 3) differ from the results presented in Progress Report No. 8. A post-test calibration check on the depth gage, used to measure pit depth, showed the gage was out of calibration. The correct values are reported here. Figure 4.6 shows the pitting in elbow #2, with two large, elongated pits and a number of smaller, circular pits. Based on the maximum pit depth of 0.048", the maximum wear rate for Test 3 was 270 MPY.

The pattern of wear seen in the elbows for Test 3 suggests that the flow was partially stratified, and a liquid film protected the bottom half of the pipe from droplet impingement wear. Some stratification of the flow was expected since the flow conditions were selected to be just above the transition from stratified-wavy flow to annular mist flow. The presence of two distinct types of pitting wear (circular pits and those elongated in the direction of flow) at different elevations in the elbow also indicated local flow conditions and wear mechanisms changed with elevation. The results of Test 3 confirmed that significant flow-induced wear could occur in elbows, even when operating well below the erosional velocity limit in API-RP-14E.

Figure 4.6 Inside Surface of Fitting #2 in Test 3. Flow is From Right to Left. Top of Pipe is Up.

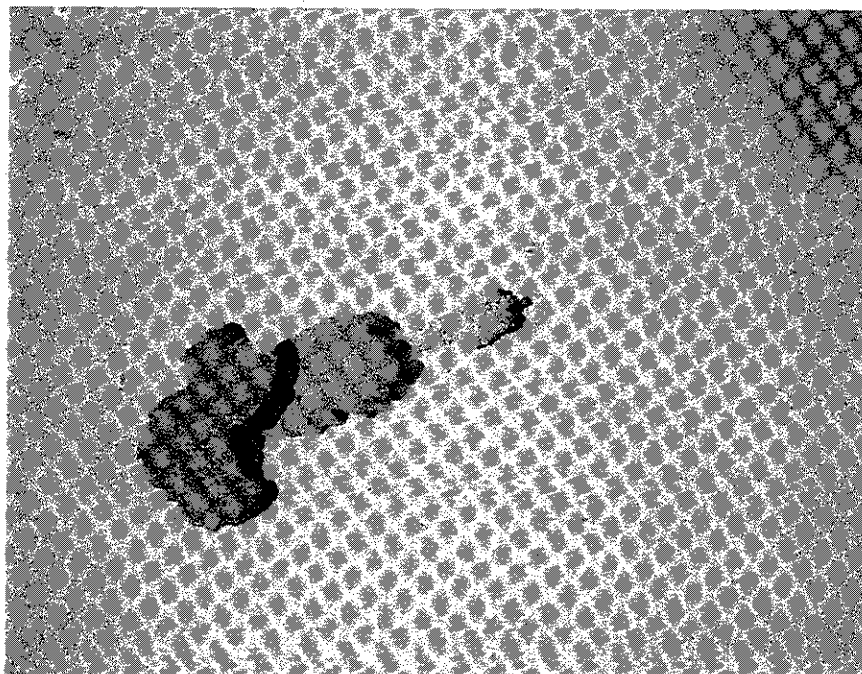
Fitting #1 had one large pit that looked like 3 pits that formed in a row (they were connected). The row of pits grew wider and deeper in the downstream direction, as shown in the closeup view of the pit in Figure 4.7. The pit was located 55° from the elbow inlet, and 0.5" above the pipe centerline. The maximum pit width was 0.21", and the overall length was 0.4". The depth of the three segments of the pit increased from 0.022" to 0.048" to 0.078". As shown in Figure 4.7, the

Figure 4.7 Close-up View of Pit in Fitting #1 in Test 4. Flow is from Right to Left. Top of Fitting is Up.

string of pits did not grow straight downstream, but angled downward at about 20° relative to the pipe centerline axis. This same trend was seen in the other elbows, with the magnitude of the angle increasing with the distance from the centerline.

Based on a maximum measured pit depth of 0.078", the maximum wear rate for Test 4 was 508 MPY. This high wear rate occurred while operating at 45% of the allowable erosional velocity in API-RP-14E. The wear pattern in the elbows showed more attack in the top half of the elbow. The bottom half appeared to have been covered with a protective liquid film. Observations of the stratified-wavy flow regime in a transparent test section (at gas and liquid superficial velocities of 50 ft/sec and 0.5 ft/sec, respectively) showed significant droplet generation from the tops of the liquid waves. These droplets became entrained in the gas and impinged on the outside of the elbow bend. Thus, even though the flow regime was not annular mist, droplet impingement was still occurring in the top half of the elbow.
